Ideal Cooperage  
Jersey City, New Jersey

DOCUMENTATION RECORDS  
FOR  
HAZARD RANKING SYSTEM

HAZARDOUS WASTE SITE INVESTIGATION  
Ideal Cooperage  
Jersey City, New Jersey

TDD No. 02-8104-06

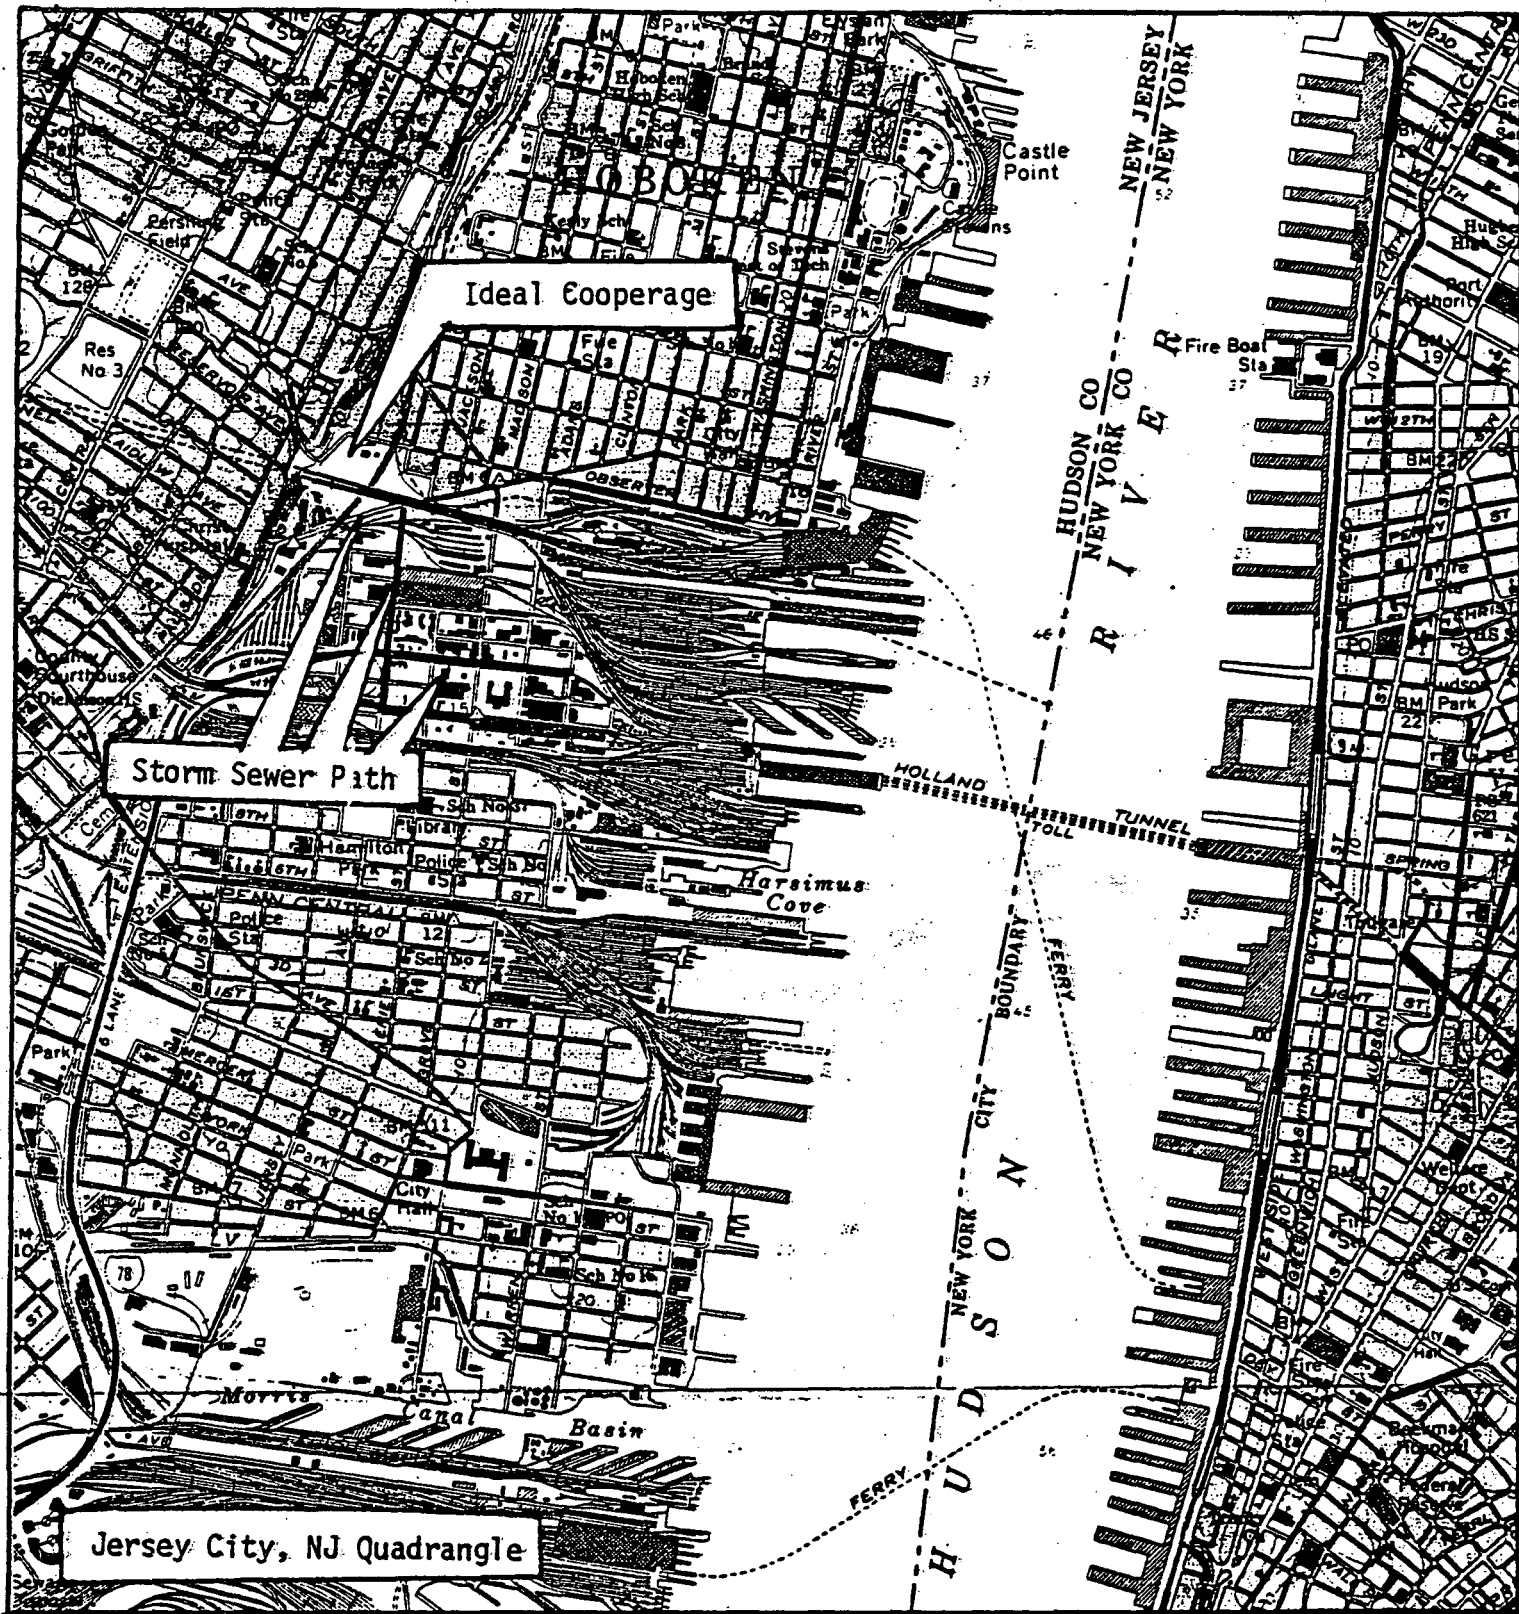
Figure 1  
Ideal Cooperage

As shown in Figure 1 the site is located at the base of a 90 foot tall cliff which separates a residential neighborhood in Jersey City from a heavily industrial and residential area to the east of Jersey City and Hoboken. New York Avenue connects the two areas. The lower industrial area which Ideal Cooperage is adjacent to, includes the passenger terminal of the Erie-Lackawanna Railroad and Conrail's repair and freight yards along the Hudson River. The western terminal of the Holland Tunnel and heavily traveled Routes 1&9 are also located less than a mile away.
